Clean Air Act 112(r) INSPECTION REPORT

Name: Big Ox Energy- Siouxland, LLC	
Address: 1616 D Ave. Dakota City, NE 68731	Date of Inspection: 2/13 - 15/2017
County: Dakota	Case No: 17NE0213
Phone: 844-491-1953	RMP No: N/A
High Risk: No	FRS No: 110064587656
Title V: No (NDEQ CP15-008)	Program Level: General Duty Clause
Mailing Address: 6601 County Road R, Denmark, WI 54208	
Process: Biogas production from anaerobic digestion of waste water from multiple sources. NAICS: 325199 - All other basic organic chemical manufacturing

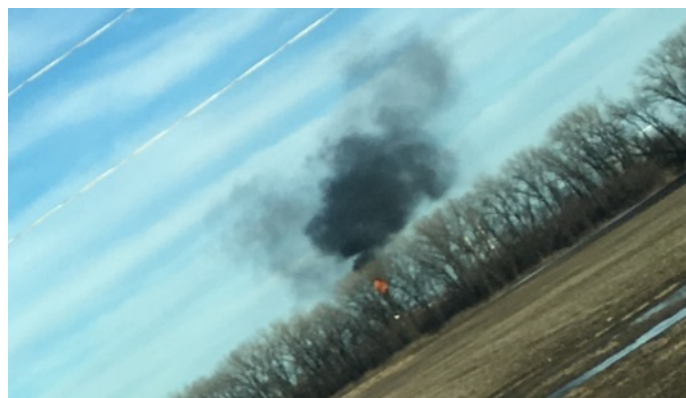
Upon reaching Highway 75 to the west of the facility, Laura and I noticed black smoke and flame coming from Big Ox’s flare. Recorded in Photographs 1 to 7 in Attachment 3, and presented below.

Photo 1: Smoke and Flame from Flare on February 13, 2017, from Highway 75 facing east, cropped and centered (Attachment 3)

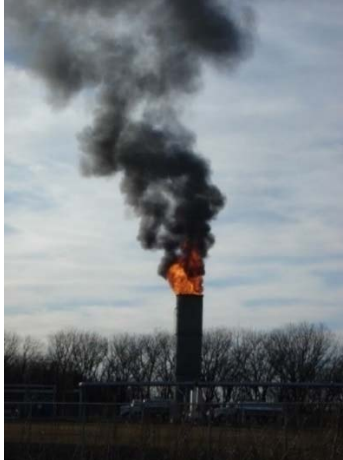
Photo No. 4: Smoke and Flame from Flare on February 13, 2017, from railway access road, facing northwest, DSC01718 taken by Sean Bergin (Attachment 3)

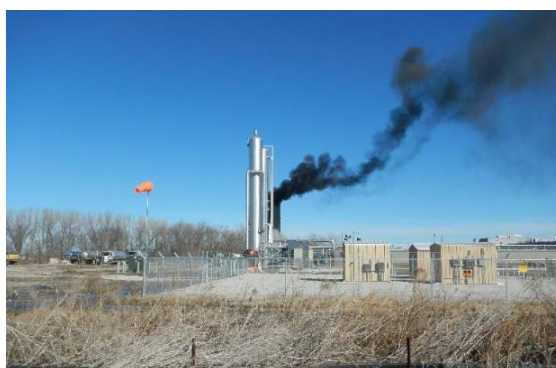
Photo No. 8: Smoke from Flare on February 13, 2017, facing north, DSCN0193, taken by Sean Bergin, Cropped (Attachment 3)

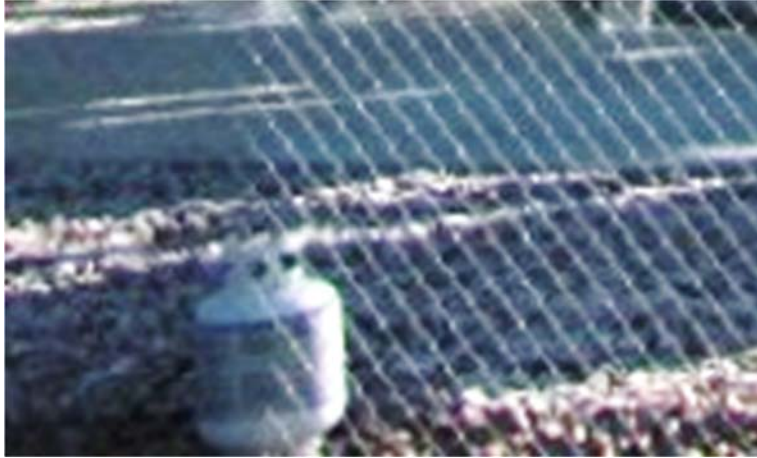
While inspecting this area, Laura observed a propane tank and torch leaning against the fence. Laura inquired concerning this device to Perry Winkler. He indicated this was used to unfreeze lines. While not clear if this was used on water or gas lines, Laura clearly indicated to him that this is unacceptable practice on a flammable system and should be removed from the facility. Perry indicated that it would be.

Photo No. 11: Biogas Clean Up Skid, facing east, IMG_0200, taken by Dave Hensley, Cropped, Brightness Adjusted, and Centered to Show Propane Tank (Attachment 3)

The propane flame heat source in area of the biogas clean up skid handling methane might have been identified as a hazard and not used. Big Ox has identified some areas that have electrical classification such to prevent entry of non-intrinsically safe equipment.

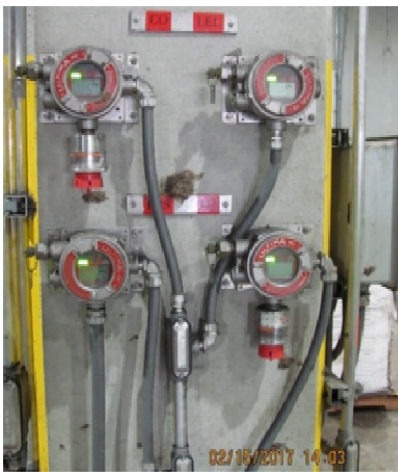
Big Ox utilizes personal protective equipment, such as hard hats, safety glasses, face shields, and chemical spill suits, to minimize the consequences of releases to employees. They also have safety showers located in the facility as well as a portable safety shower that can be moved to different areas for specific projects. I observed that fire extinguishers were placed throughout the facility. Two identical air monitoring stations are used to monitor the air quality inside the building, one on the north end and one on the south end of the digester building. I asked permission, and took photographs of the air monitor on the north end of the building (Photo No. 18 to 24). This system monitors oxygen, carbon monoxide, hydrogen sulfide, and lower explosive limit. According to a discussion with Perry, an audible and visual alarm would notify workers in the area, and an alarm would appear on control displays.

Photo No. 19: Air Monitors in North End of Process Building, facing east, IMG_0208, taken by Dave Hensley, cropped, (Attachment 3)
